Case Study: Food Service Supplier

Global Food Service Supplier - Sydney, Australia

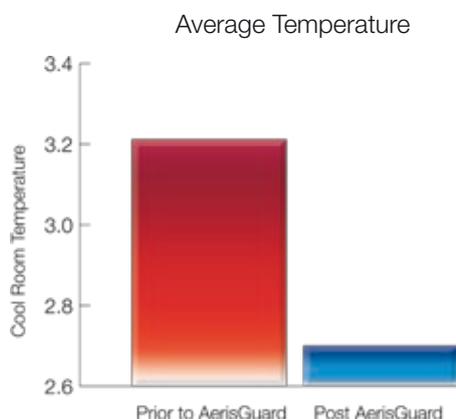
The AerisGuard treatment delivered dramatic improvements in the units treated in terms of a decrease in average temperature of 16% and a decrease in the temperature variability of 21%. Given that the units are located in the loading dock, the temperature variability is a key indicator of the performance of the refrigeration system.

16% Reduction In Average Temperature

Post treatment, there was a 16% reduction in the average temperature of the cool room and a 21% decrease in temperature variability. The temperature variability is particularly significant as it measures the system’s ability to be able to respond to heat load. The unit that was studied during the treatment was in the loading dock and is open to the outside air.

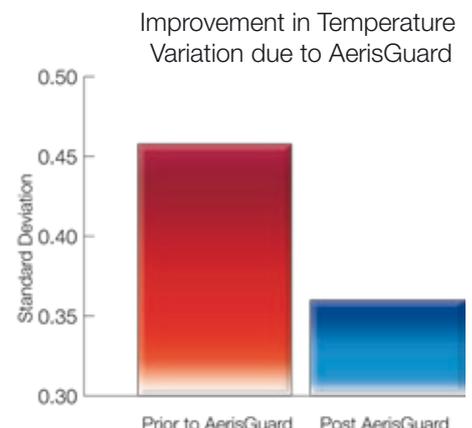
21% Reduction In Temperature Variation
