AERIS GUARD  
**MULTI-ENZYMATIC  
CLEANING AND  
SANITISING OF  
HOSPITAL WATER  
COOLING TOWER**

## EXECUTIVE SUMMARY

This remediation was undertaken by an Aeris Platinum Partner, in Malaysia with technical support from Aeris Environmental, Australia in June 2016.

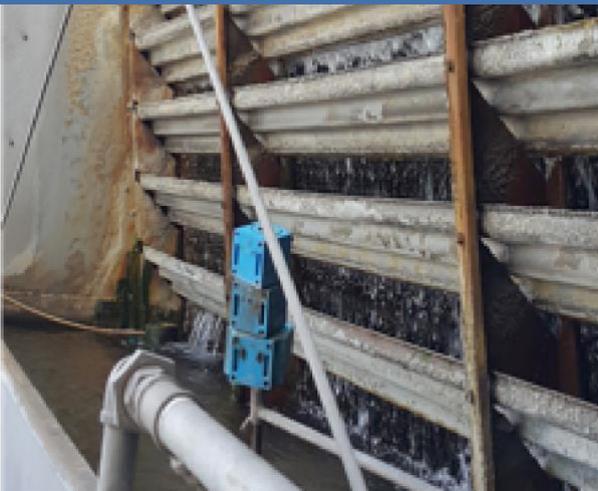
### BEFORE

*The cooling tower before cleaning*

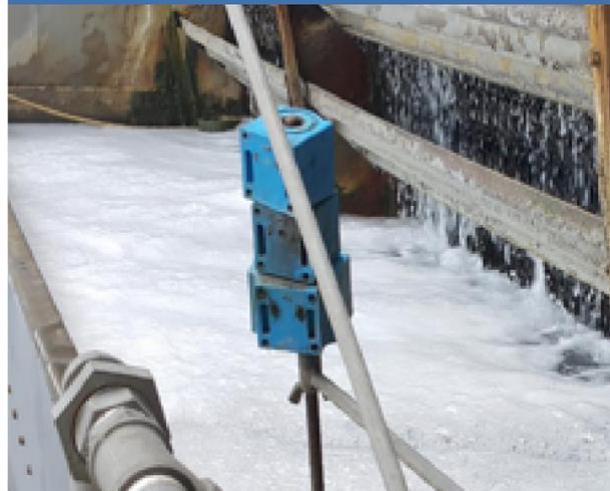
### AFTER

*The Enzyme reaction in the basin*

As the AMCS was added to the basin the water shows active micro-bubbles and clouding as the enzymes begin to break down the protective outer layers of the Bio-cide.

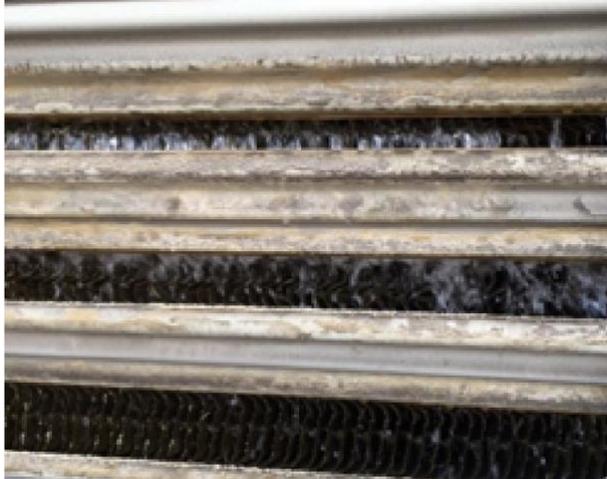
**BEFORE**

The pictures below shows the water running down the outside of the cooling tower fill. For optimum heat dissipation the fill is designed to have the water pass over it. With this fill having excess microbial build up water was bypassing the fill.

*Water flow before treatment***AFTER**

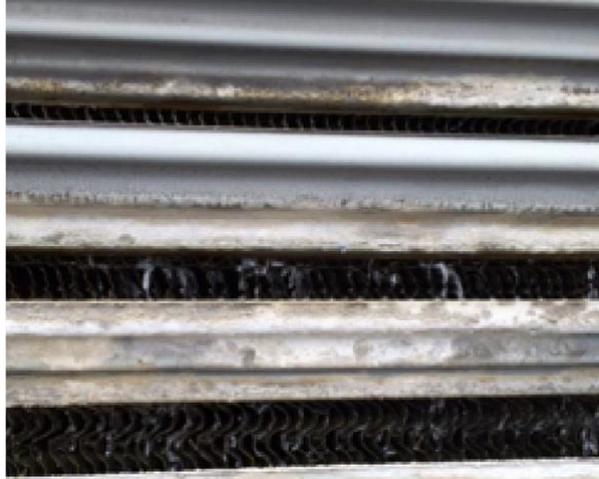
*Water flow after treatment*

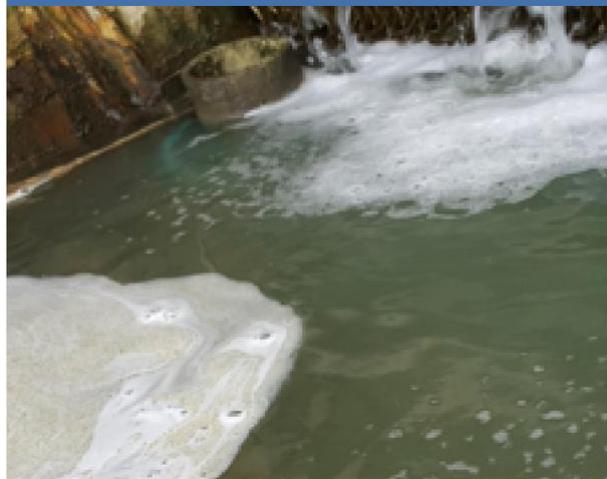
**BEFORE**

The water surface was largely clear of any visible scum or Bio-film prior to treatment being added to the basin. 24 hours after adding the AMCS there was very visible area's where the Bio-film cleaned from the tower by adding the AMCS had gathered to form a visible scum layer on the surface of the water.

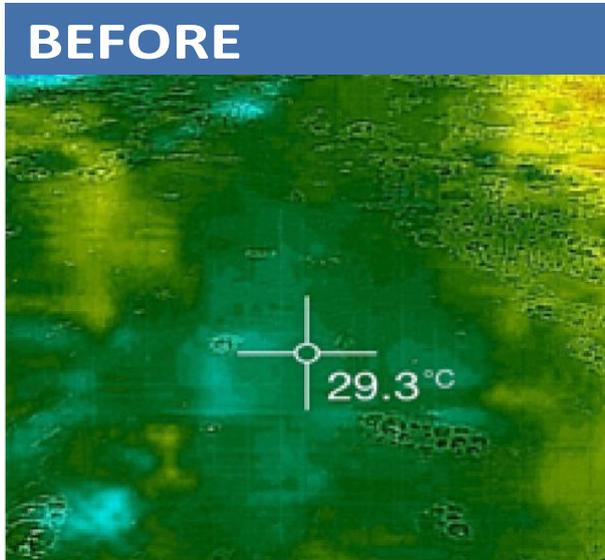
As shown below the water temperature also dropped from 29.3°C before cleaning to 27.9°C after. This demonstrates through clearing the Bio-film, the cleaning process was able to greatly increase the efficacy of the heat exchange within the cooling tower.

*Temperature before treatment*

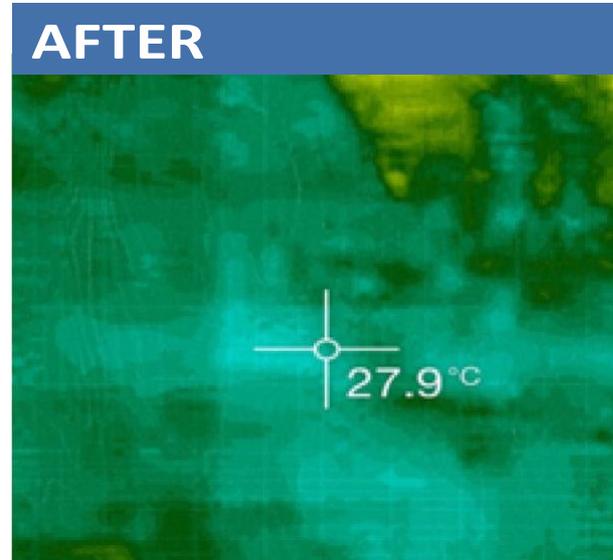
*Temperature after treatment*

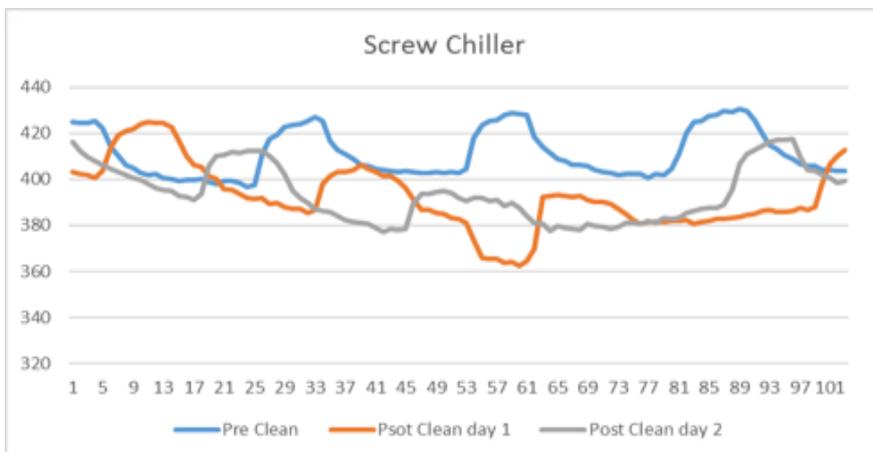
The graph below is the analysis of the recorded data and identifies a reduced ramping in the operation of the compressor motor in the chiller operation following the cleaning of the cooling tower. This could be attributed to the reduced condenser water temperature from the clean tower.

The average energy saving identified through performing the remediation process was 4.36%, which is an added benefit to the essential need to maintain a clear and clean cooling system free from Bio-film build-up.
