Case Study: Supermarket

Major Supermarket Cool Room - WA, Australia

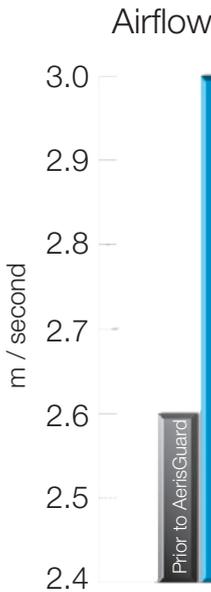
15% Improvement

The outstanding results are displayed in the graphs at the bottom of the page one. There was a 15% increase in airflow – increasing from 2.6 m/sec to an impressive 3.0 m/sec.

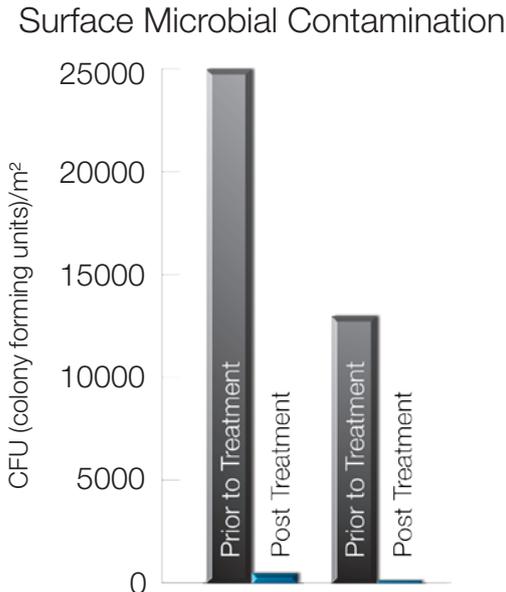
Almost Disappears

The microbial analysis explains the results achieved. Pre-trial locations had “Very High” to “Extremely High” surface concentrations of fungi. The main species were typical “Water-Loving” fungi. The presence of *Trichoderma* sp. indicated that the mould growth was not recent.

Post trial location samples showed no fungal growth or growth at the detection level of a single colony (less than 421 CFU/m²).

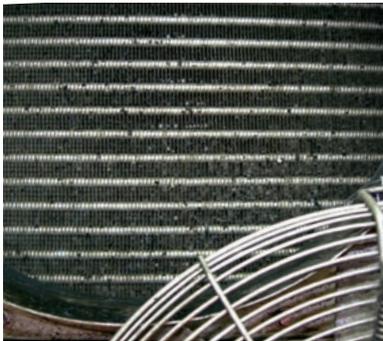
Air on: prior to AerisGuard* treatment

- An inspection of the FDC unit prior to treatment showed that there was heavy biological contamination of the heat exchange coil and surrounds
- A remediation using AerisGuard™ products was thought by the company to be the best solution to resolve their biofilm issues
- The company requested for the remediation to be completed within 1½ hours due to the limited shelf life of the stored produce and that the stored produce remain in the Cool Room during the treatment

- AHS Coil Cleaner was diluted and applied to the FDC unit according to the SOP and left to digest the biofilm for around 25 minutes
- The FDC unit was then rinsed with water and allowed to dry, whereupon the AHS Coil Treatment was applied to provide an anti-microbial

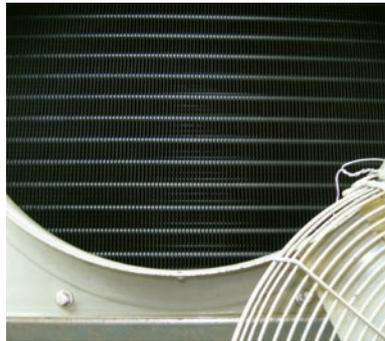
Air on: post AerisGuard* treatment

The biological contamination was successfully remediated with almost all of the biofilm successfully removed from the coil and the external surface of the FDC.

coating to the unit
